MISCELLANEOUS PAPER S-73-12

# CONDITION SURVEY, ELLSWORTH AIR FORCE BASE, SOUTH DAKOTA

P. J. Vedros

April 1973

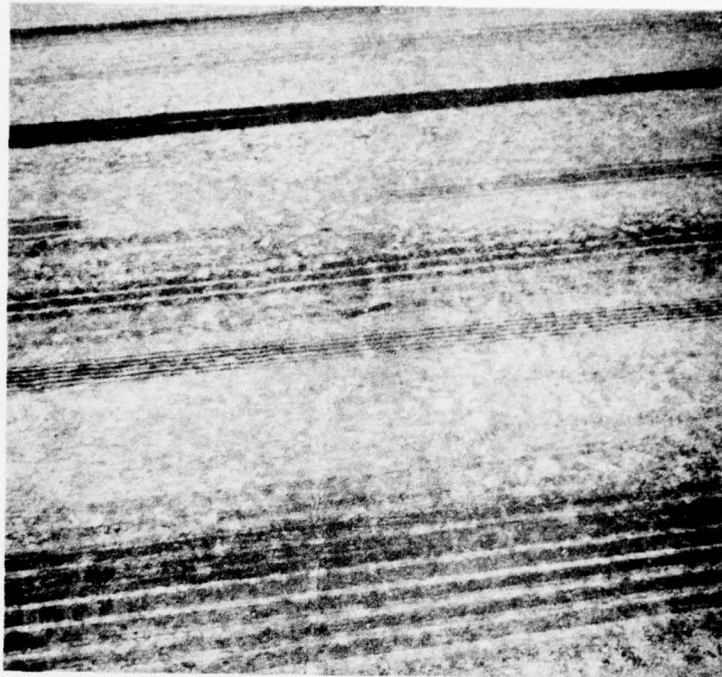
runway was considered to be excellent. The 1000-ft runway ends were in excellent condition with only two major structural defects recorded (table 3). The 75-ft inlay section of the interior portion of the runway from sta 40+06 to 65+06 (features R12C, R14C, and R15C), which consisted of 18-in. reinforced portland cement concrete (PCC), had nine slabs that contained transverse cracks. The crack openings were very small and appeared to be held tightly together by the reinforcement (photo 1). The condition of this inlay section was rated as good.

Photo 1. Transverse crack in reinforced PCC  
slab of NW-SE runway

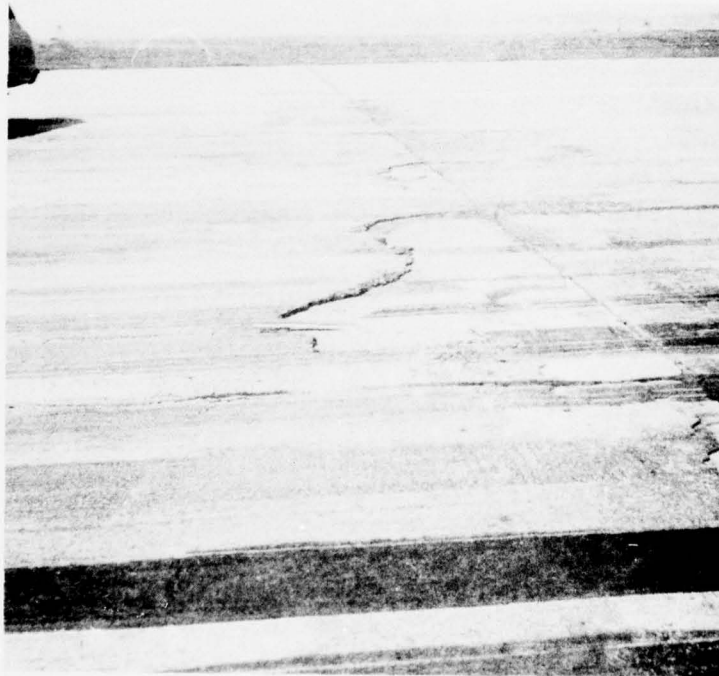
12. An asphaltic concrete (AC) overlay was placed on the runway from sta 135+30 to 160+03 in 1966 and from sta 65+06 to 135+30 in 1969; and, at the time of this survey, the overlay pavement was in excellent condition. There was evidence of some reflection cracking at the joints, with some free water in the cracks, probably from frost melting. The overlay was feathered at sta 165+03, and the edges of the overlay were raveling at this point (photo 2).

Photo 2. Raveling of feathered edge of AC  
at sta 165+03 of NW-SE runway

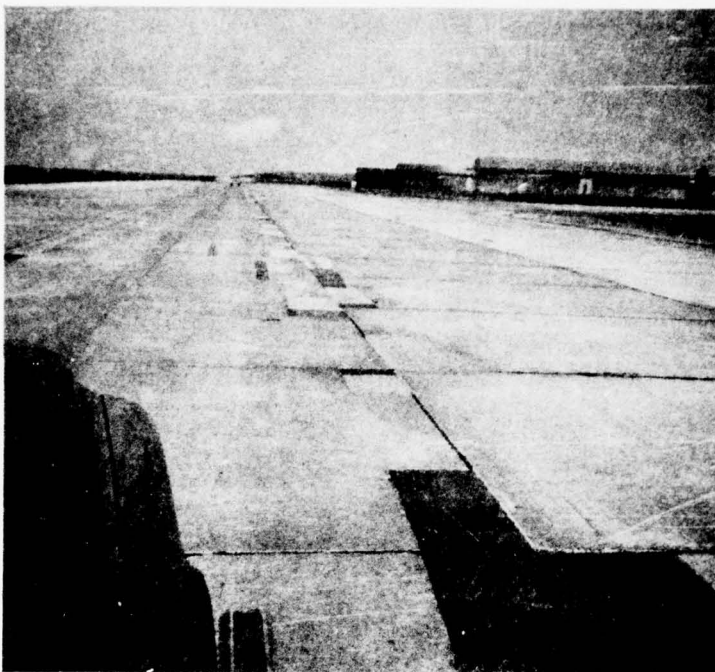
Photo 3. Patched joint spalls on taxiway 26 near parking apron. Note that patches are on each side of joint

27. Maintenance of the longitudinal spalls on the north end of taxiway 26 has consisted of sawing to a minimum depth of 2 in. in the sound concrete beyond the spalled area and chipping out the unsound concrete to the depth of the keyway. The exposed surface is then brushed with a tack coat, and hot-mix AC is used in the patch. When existing patches have settled 1/2 in. or more below the adjacent slab, additional hot-mix AC has been applied. These patches have been performing fairly well for the past 10 years. It was reported that, in the area of taxiway 26 that contained dowels, patching the spalls required the removal of only about 4 in. of unsound concrete (i.e., the depth of the patch was less than the depth of the dowel).

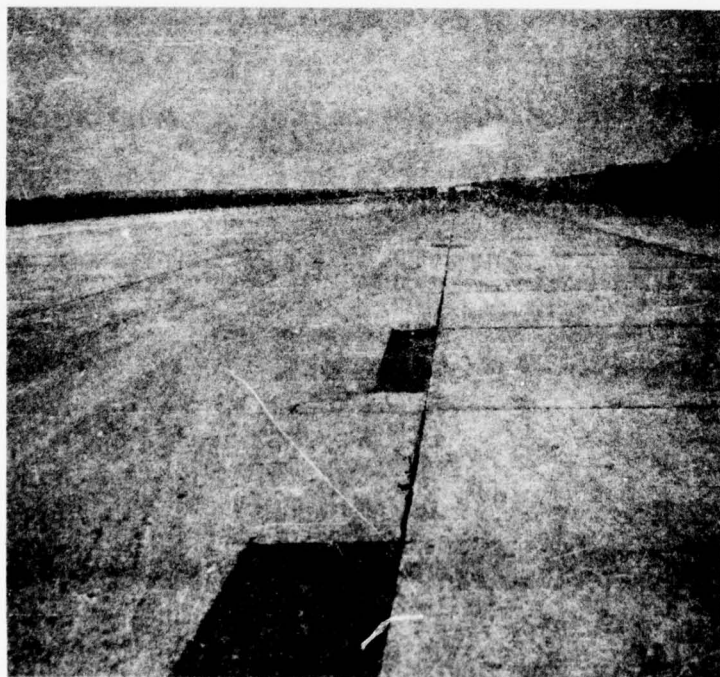
40 slabs contained longitudinal spalls that were the result of keyed joint failures. During the 1972 survey, it was estimated that approximately 163 slabs in the center lane contained longitudinal spalls that were considered to have resulted from keyed joint failures. These failed areas have been sawed out and replaced by hot-mix AC patches. The patches vary in length from several feet to the full length of a slab, and frequently the joints on both sides of the slab require patching. There were 23 slabs in this taxiway that had been replaced because they had reached a shattered condition. This feature was rated as being in fair condition, based on the defects that were recorded in the 1972 survey.

Photo 4. Patched joint spalls near north end of taxiway 26 (feature T4A)
